## Sample Homeowner Drone Inspection Report

# Homeowner Roof Inspection Report

Property: Asset Alpha (Residential Sample House)

Inspection Date: 30<sup>th</sup> January 2026

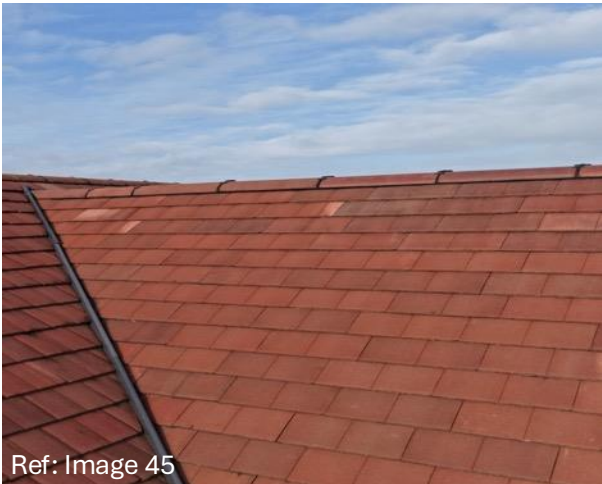
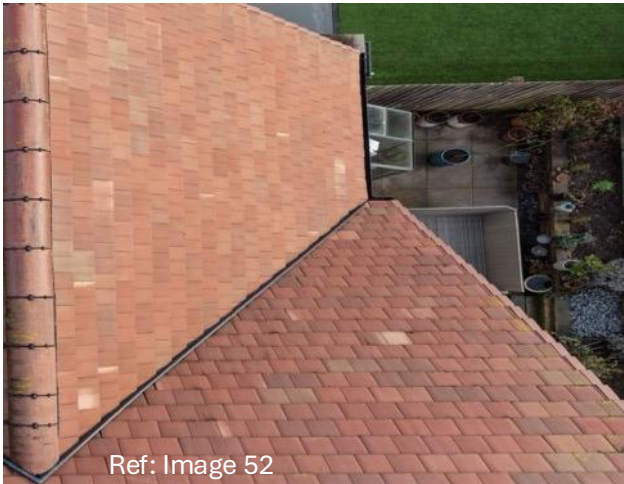
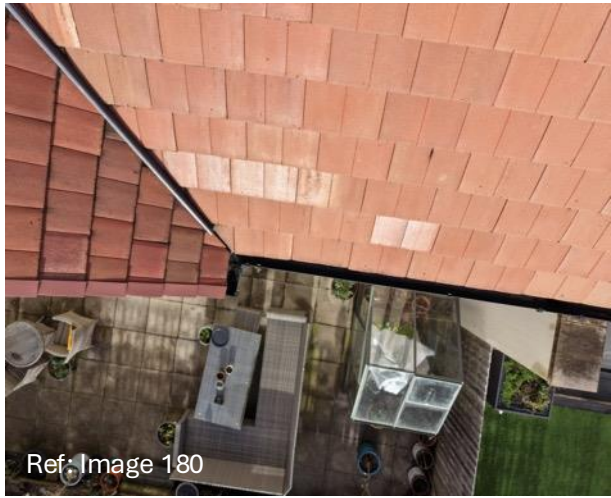
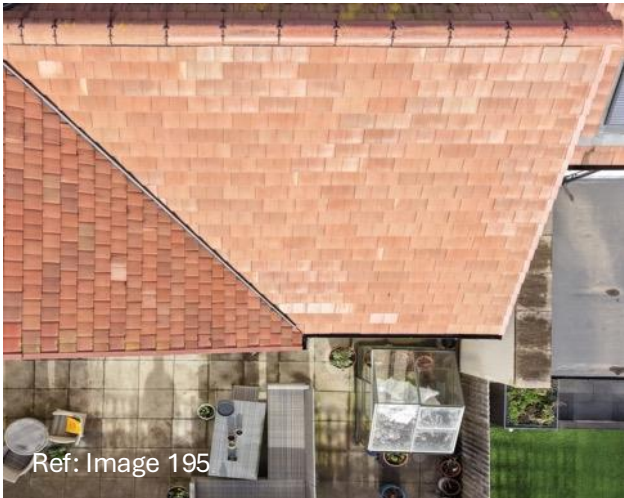
Area A : Rear Roof (Facing Back Garden)

Condition : Good

| <p>Visible Condition:</p> <p>Good</p> <p>Issue Refs: N/A</p> | <p>What we observed</p> <ul style="list-style-type: none"><li>• All concrete tiles appear straight, uniform and firmly in place with no missing sections or visible cracks.</li><li>• The cement or dry-fix ridge caps along the very top appear secure.</li><li>• Our close-up images show initial patches of green moss starting to gather on the lower left edges, but no apparent material damage at this stage.</li><li>• There is minor moss starting to grow near bottom left edges but no harm yet.</li></ul> |

The roof covering provides the property's primary defence against weather penetration. No significant defects were visible in the areas inspected, which is a positive indication that the roof is continuing to perform its intended function. Periodic inspections remain beneficial as roof coverings naturally weather over time and gradual changes can be difficult to identify from ground level.

No active work needed right now. We can log this moss pattern and compare it during your next drone check to see how fast it is spreading.

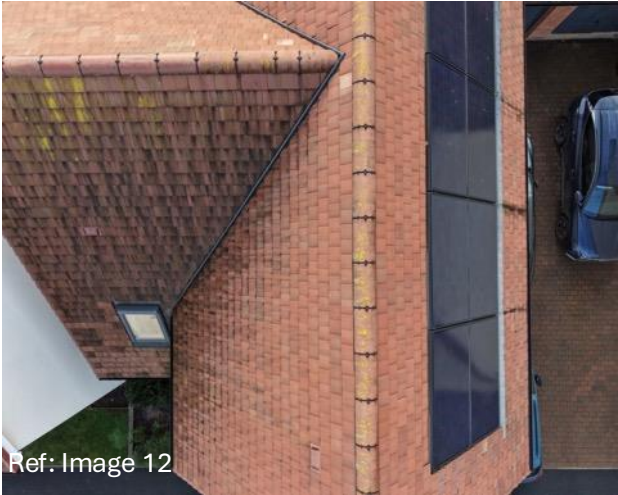
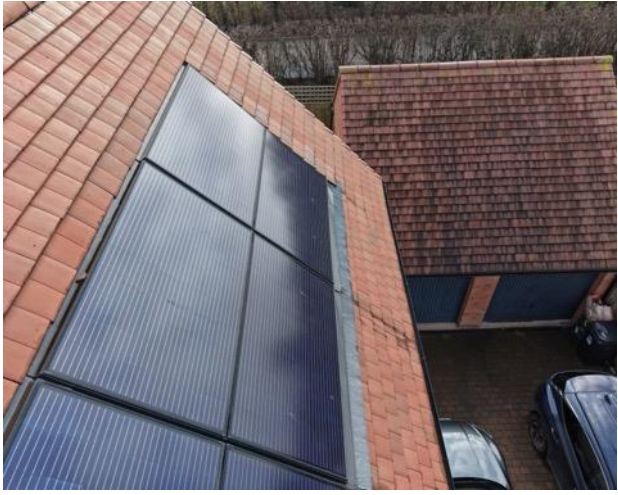
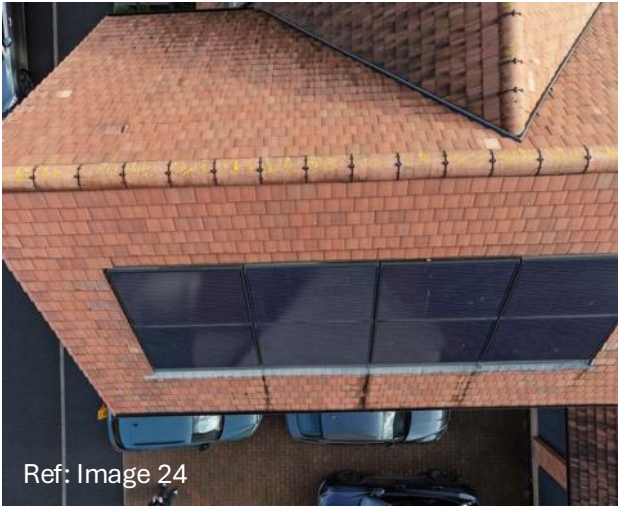
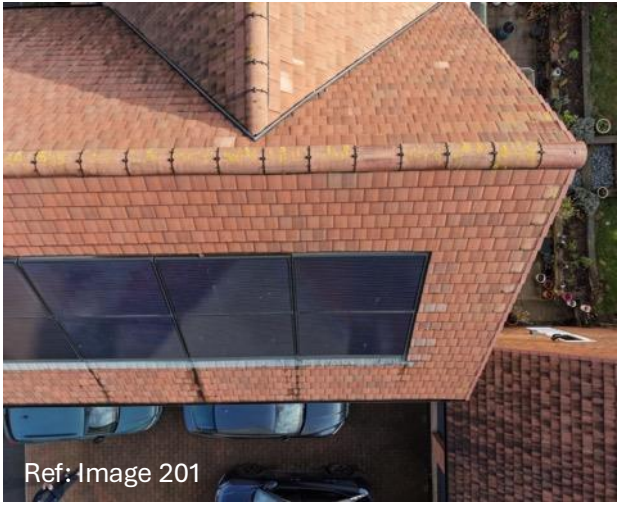
Area B : Main Roof (over Driveway / Solar Panels / West Roof Slope)

| Priority | Location on Your House | Why it matters | Suggested Next Steps |
|---|---|---|---|
| <div><div></div>Monitor</div> | Solar Panel Flashing | Localised water concentration visible beneath flashing | Ask roofer to review during routine maintenance |

Condition : Good

| <p>Visual Condition:</p> <p>Good</p> <p>Issue Refs: N/A</p> | <p>What we observed</p> <ul style="list-style-type: none"><li>• The glass surface of your solar panels look clean and free of fractures.</li><li>• However, the flexible metal trim (the flashing) running along the bottom of the solar panels looks slightly wavy, and there are distinct, dark water-tracking stains on the tiles right below it.</li><li>• This visual pattern usually happens because a solar arrays catch a lot of rain and drop on specific spots.</li></ul> |

Solar panel installations introduce additional roof penetrations and flashing details that are exposed to the elements. The observed water tracking does not necessarily indicate a defect, but it may suggest concentrated water movement in this area. Monitoring helps identify whether the condition remains stable or develops further over time.

No immediate repairs appear necessary. However, because water is concentrating heavily here, it would be wise to have a professional roofer visually inspect these seals up close during their next routine visit.

[ ] Solar Array Flashing: Please check the waterproof flashing strip directly beneath the driveway-side solar panels. The aerial photos show distinct water-tracking stains on the tiles below it. Please confirm if the flashing is still performing correctly and remains fully watertight.

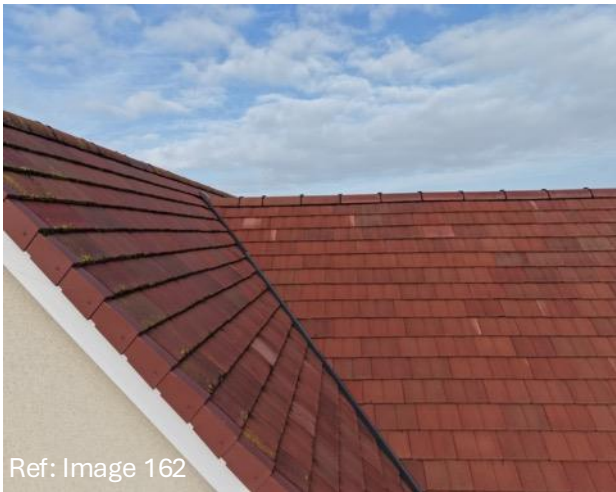
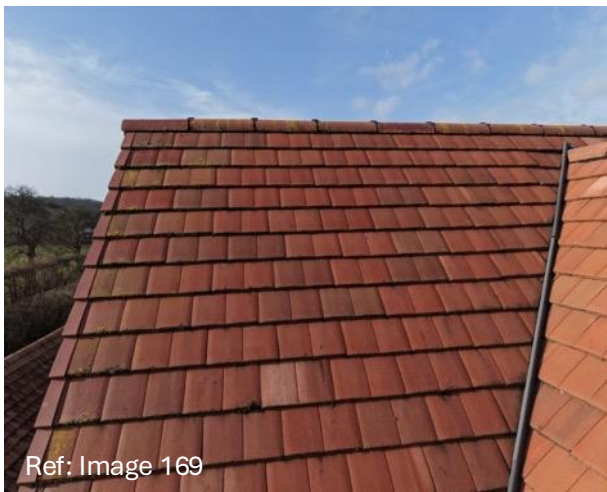
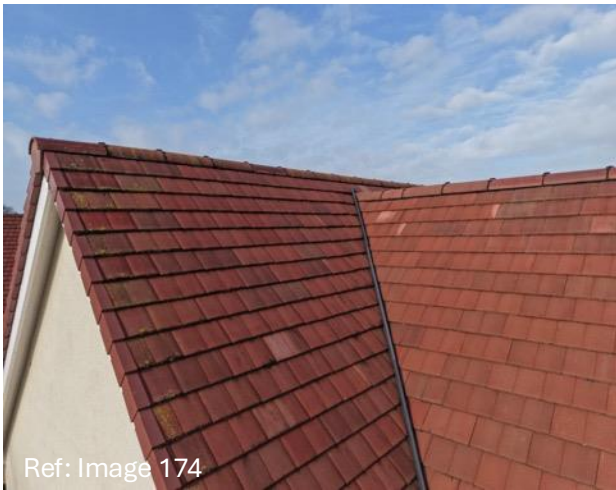
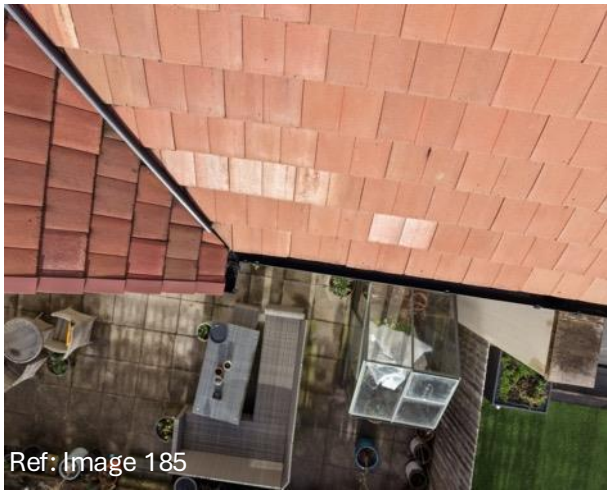
Area C : Main Roof Rear (Elevated Main Roof Slope East Facing / Garden Side)

Condition : Good

| <p>Visual Condition:</p> <p>Good</p> <p>Issue Refs: N/A</p> | <p>What we observed:</p> <ul style="list-style-type: none"><li>• Tiles appear consistently aligned, straight and unbroken.</li><li>• Light green moss accumulation is visible along the outer gable edges and lower lip of the tiles.</li><li>• Localised weathering observed in valley termination towards the patio area.</li></ul> |

Roof coverings naturally weather as they age and are continually exposed to rainfall, sunlight and seasonal temperature changes. The minor moss growth and localised weathering observed do not currently appear significant, but these conditions can gradually develop over time. Periodic inspections help establish whether the roof remains stable or whether maintenance may eventually be required

No active repairs or immediate maintenance are visible from these photographs. The roof covering is performing as expected for its age. The moss accumulation is currently minor and superficial. We suggest asking your roofer to give these valley linings a standard visual check whenever they are next on a ladder cleaning out your front gutters, just to ensure no loose moss is gathering further down the channel.

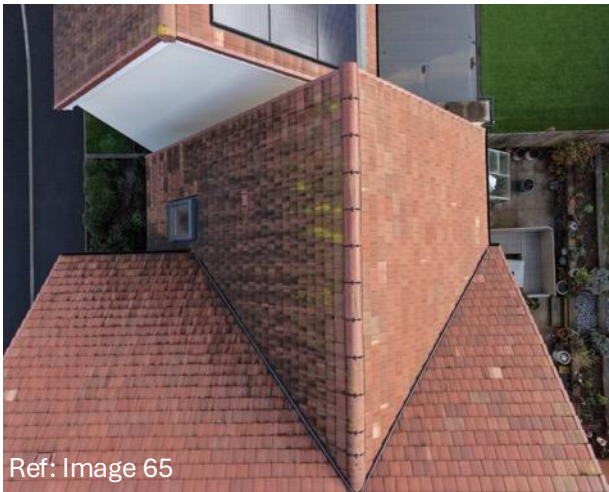
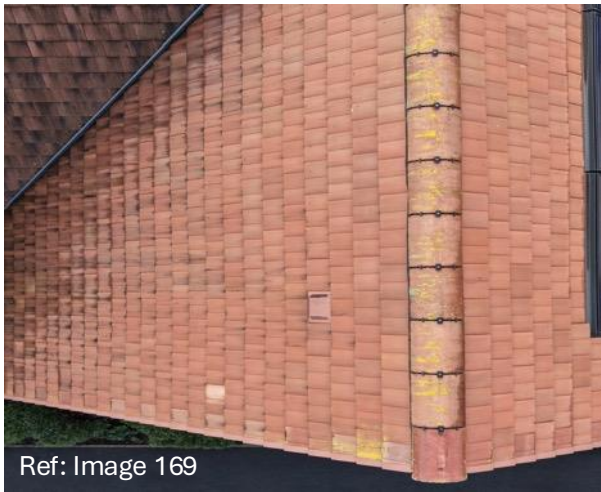
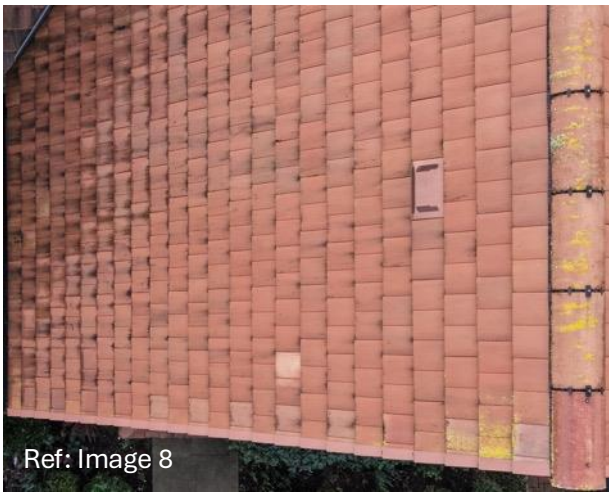
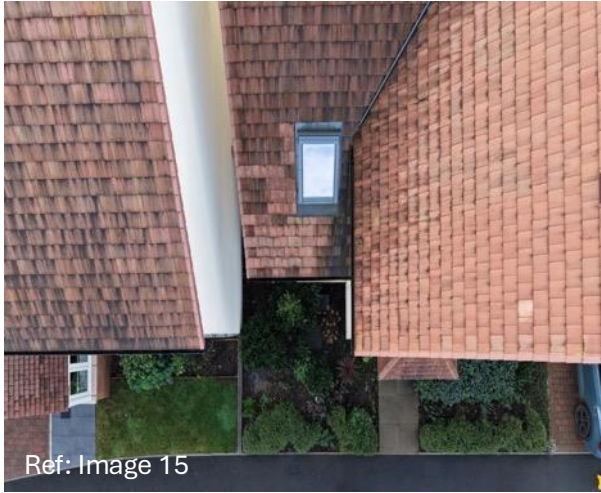
Area D : Front Roof (Elevated Main Roof Slope East Facing / Road)

Condition : Good

| <p>Visual Condition:</p> <p>Good</p> <p>Issue Refs: N/A</p> | <p>What we observed:</p> <ul style="list-style-type: none"><li>• Elevated ridge tiles running across the peak of the roof appear mechanically secure and straight. There is noticeable accumulation of yellow and green lichen/moss growing directly along these ridge caps.</li><li>• No signs of missing broken or slipped tiles.</li><li>• The roof slope is showing early signs of light, vertical water tracking lines running down the ridge caps, along with minor organic spotting.</li></ul> |

The ridge line and roof slope appear visually stable, with no significant defects visible from the aerial imagery obtained. Recording the current condition provides a useful reference point for future inspections and helps identify any developing changes over time

Because this is the highest, most exposed section of your roof, it gets better sunlight and airflow, which is keeping it much drier than the lower areas. No immediate maintenance or structural repairs are indicated here. We suggest having a roofer visually check the condition of the ridge tile bedding mortar the next time they are on-site to ensure the lichen isn't degrading the seals.

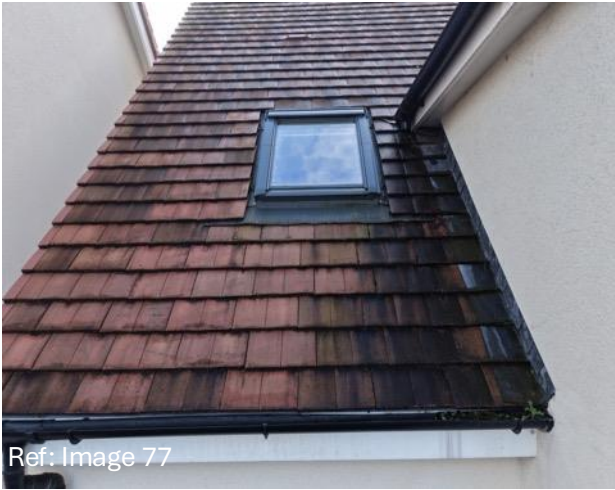
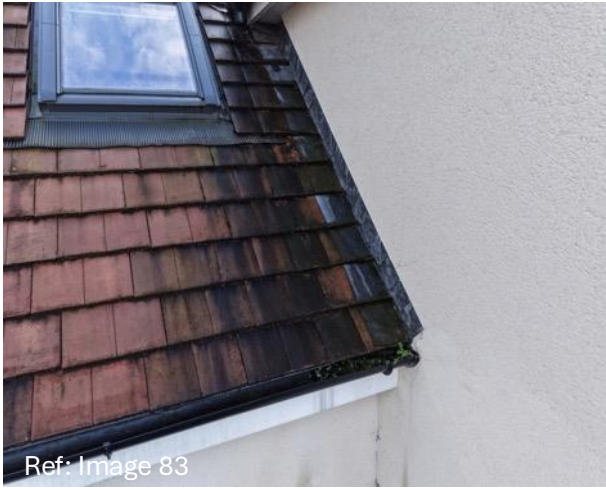
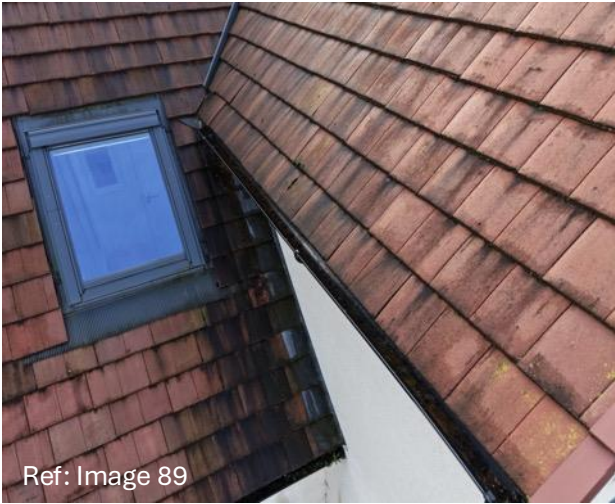
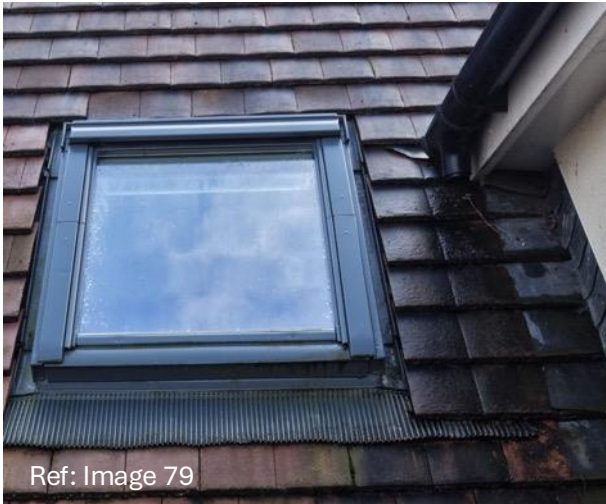
Area E : Front Roof (North Roof Slope / Road)

| Priority | Location on Your House | Why it matters | Suggested Next Steps |
|---|---|---|---|
| <div><div></div>Action Recommended</div> | Front gutter blockage | Overflowing water may increase moisture exposure around roof and wall elements | Arrange gutter clearance and drainage assessment |

Condition :Action Recommended

| <p>Visual Condition:</p> <p>Action Recommended</p> <p>Issue Refs: N/A</p> | <p>What we observed:</p> <ul style="list-style-type: none"><li>• North facing slope gets little direct sunlight, which means stays damp for longer.</li><li>• Tiles show significant black water staining and extensive green algae growth.</li><li>• We observed a severe blockage in the guttering, which is entirely choked with thick moss and weeds.</li><li>• Because no downpipe on this section, water is visibly spilling over the side of the gutter onto the walls and underlying structural elements</li></ul> |

When gutters become blocked, water may overflow onto adjacent roof and wall elements rather than draining as intended. Over time, persistent overflow can increase moisture exposure and accelerate deterioration of surrounding building components.

We highly recommend calling a professional gutter cleaner or roofer to investigate this area. The gutters need clearing, and a professional can assess whether any improvements to drainage provision may be beneficial.

[ ] Front Gutter Blockage & Drainage: Please physically check or advise on the north-facing front gutter (located over the front door and Velux window). Our aerial photos show it is heavily choked with moss and overflowing. Please clear out the debris and advise if a downpipe extension or water diverter should be installed to prevent ongoing water cascading.

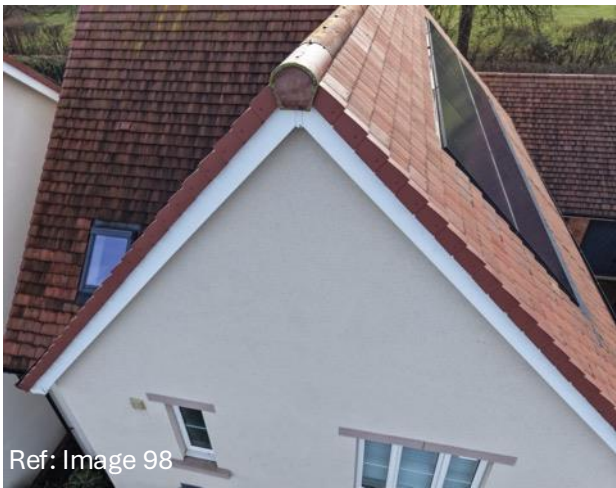
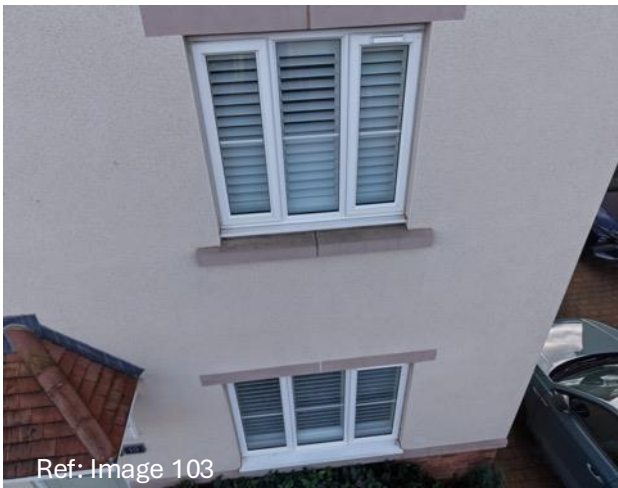
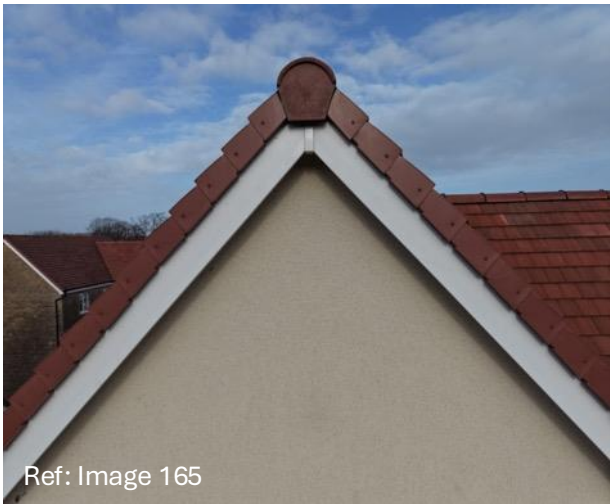
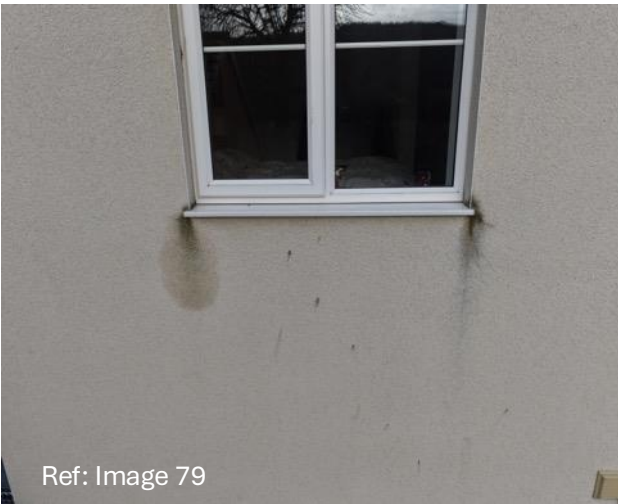
Areas F :Windows, Brickwork, and Plastic Trim

| Priority | Location on Your House | Why it matters | Suggested Next Steps |
|---|---|---|---|
| <div><div></div>Monitor</div> | Rear window staining | May indicate drainage inefficiency | Observe during periods of heave rainfall |

Condition : Good

| <p>Visual Condition:</p> <p>Good</p> <p>Issue Refs: N/A</p> | <p>What we observed:</p> <ul style="list-style-type: none"><li>• Plastic roof trim (soffits and fascias) look straight and securely attached.</li><li>• Porch above entrance showing typical aging to the mortar joints, but appears solid.</li><li>• At the rear we captured dark vertical tear-shaped stains on the external plaster directly below the rear west window sill.</li></ul> |

External staining patterns can sometimes indicate how water is moving across building surfaces. While no immediate concern is evident from the imagery obtained, monitoring this area may help identify whether the staining remains cosmetic or develops into a more persistent drainage-related issue. Monitoring mortar joints is important to avoid water ingress.

On the windows this staining often indicates that a window's built-in drainage holes are blocked, or the sill isn't tipping water away from the wall correctly. We suggest checking that the window's internal plastic drainage paths are clear of dust, and asking a window specialist to take a look if you notice any dampness inside.

[ ] Rear West Window Staining: Please look at the exterior wall directly underneath the rear west window sill. There are visual run-off stains on the plaster. Please check the window seals and drainage weep-holes to ensure water is shedding away from the building fabric correctly.
